ANG Hancock Site Assessment Summary

February 17, 2005 Meeting

Site Assessment Summary

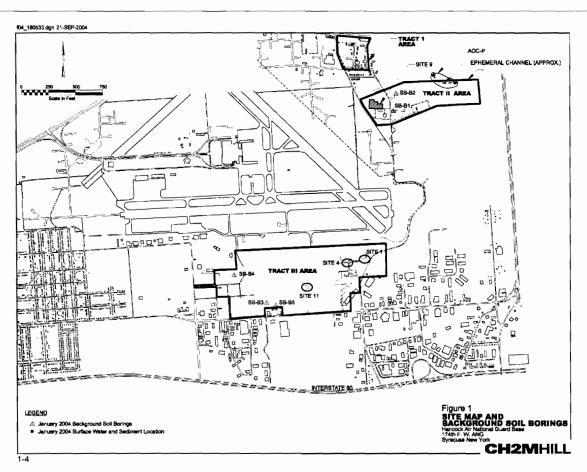
Site Background Soil Sampling

- > History
- Investigation
 - 5 Soil Borings
 - 3 Samples each boring
 - VOC, SVOCs, Metals
- > Findings
 - Establishment of Background Metals Conc.
 - Detections of SVOCs limited to surface soils

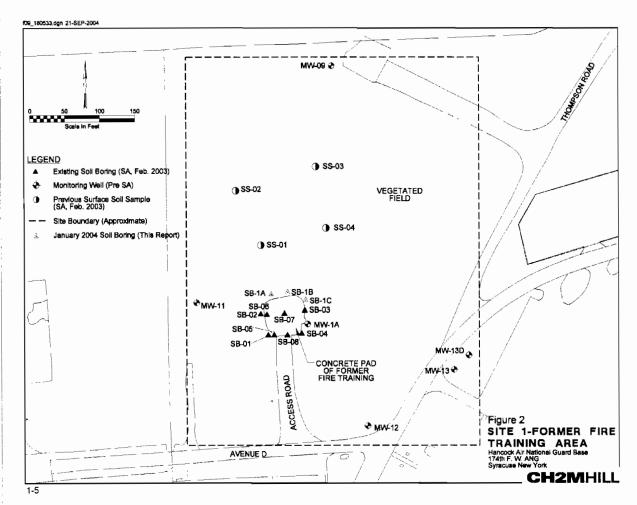
Site 1 – Former Fire Training Area

- > History
 - Flammable liquids used for accelerant
- Previous Investigations
 - 8 SB, 5 MWs, 4 surface soil, and 4 concrete samples
- > SA Investigations
 - 3 SB, 1 MW, GW sampling
 - VOCs, SVOCs, Metals (F/U)
- > Findings
 - VOCs and SVOCs in soils (limited extent)
 - Metals in soil and GW (Mg and Ni)

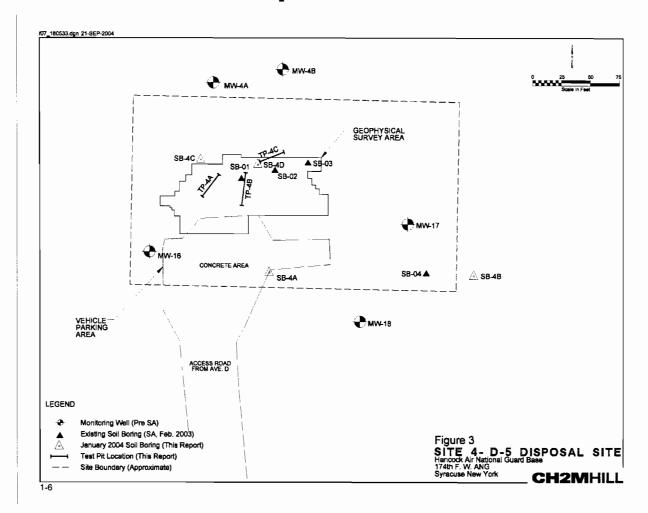
Site 4 – D-5 Disposal Site

- > History
 - 100 x 150 ft disposal area
- Previous Investigations
 - Geophysical anomalies
 - 4 SBs and 3 MWs installed
- > SA Investigations
 - 3 Test Pits, 4 SBs, and 2 MWs
- > Findings
 - Metal Debris
 - SVOCs in deep soil
 - Metals in GW

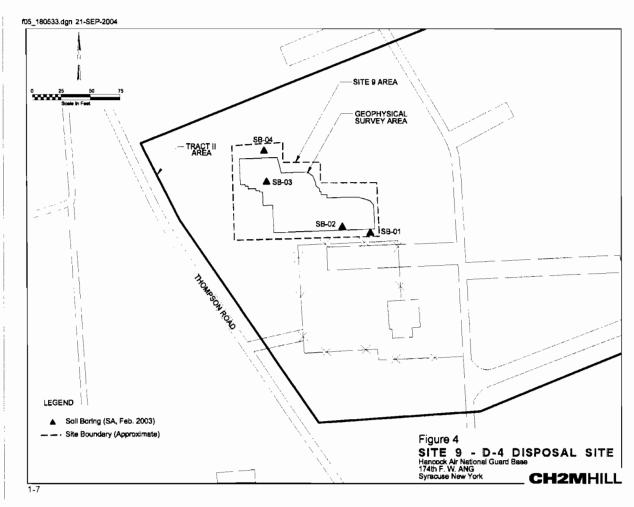
Site 9 – D-4 Disposal Site

- > History
 - Small disposal area
- Previous Investigations
 - Geophysical survey, 4 SBs, 1 TWP
- > SA Investigations
 - Establish Background Metals Conc.
- > Findings
 - Limited metals exceedances above established background

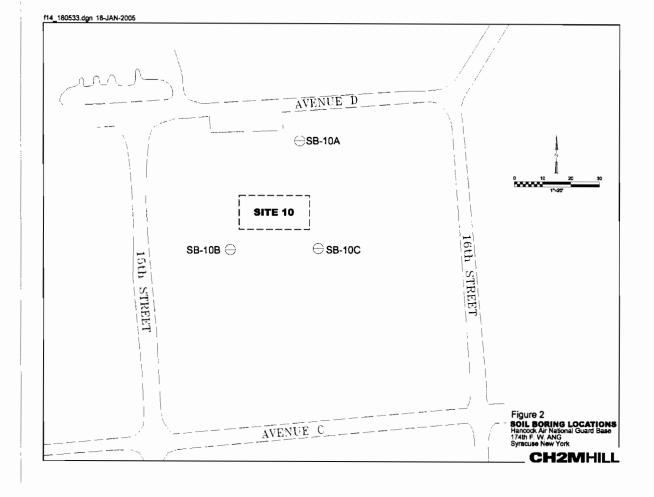
Site 10 – Hazardous Storage Area

- > History
 - Storage building for pesticides and PCBs
- Previous Investigations
 - None
- > SA Investigations
 - 3 SBs (6 samples)
 - Pest, PCB, Metals
- > Findings
 - Pest/PCB detections below standards
 - Metal exceedances limited

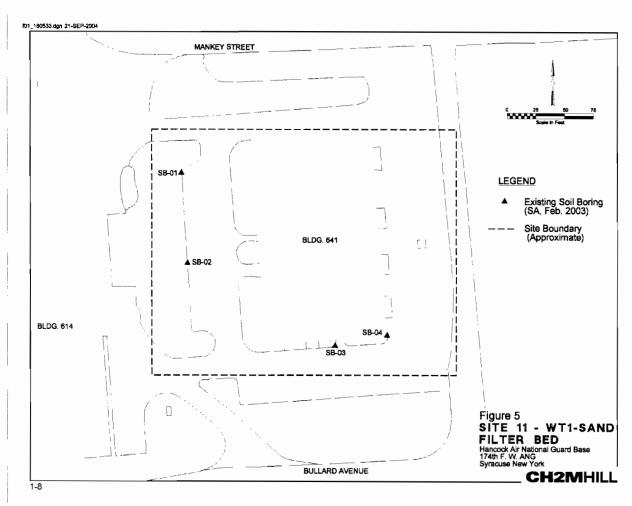
Site 11 – WT-1 Sand Filter Bed

- History
 - Former water treatment filter beds (building constructed over area)
- Previous Investigations
 - 4 SB, 2 TWPs
 - Only pot. metals exceedances
- SA Investigations
 - Establish
 Background for Metals in Soil
- > Findings
 - Limited metals exceedances above established background

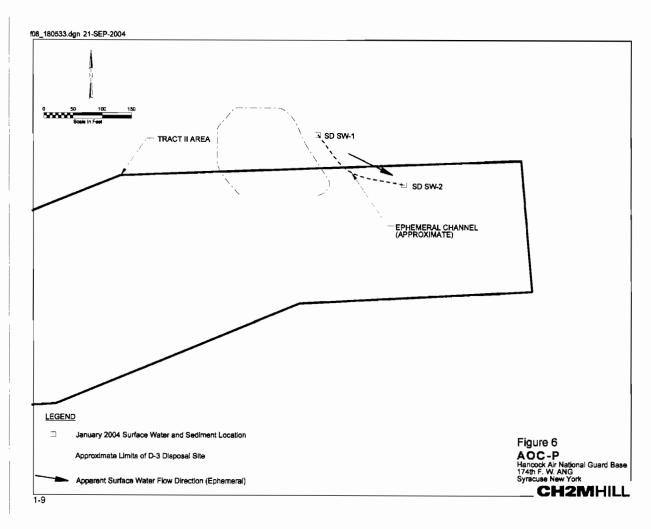
Site AOC-P - Area

- History
 - Ephemeral stream near Landfill Disposal Site
- Previous Investigations
 - SW/SED samples exceeded for metals
- > SA Investigations
 - 2 SW and 2 SED samples
- > Findings
 - 2 metals above background in SED, not affecting SW quality

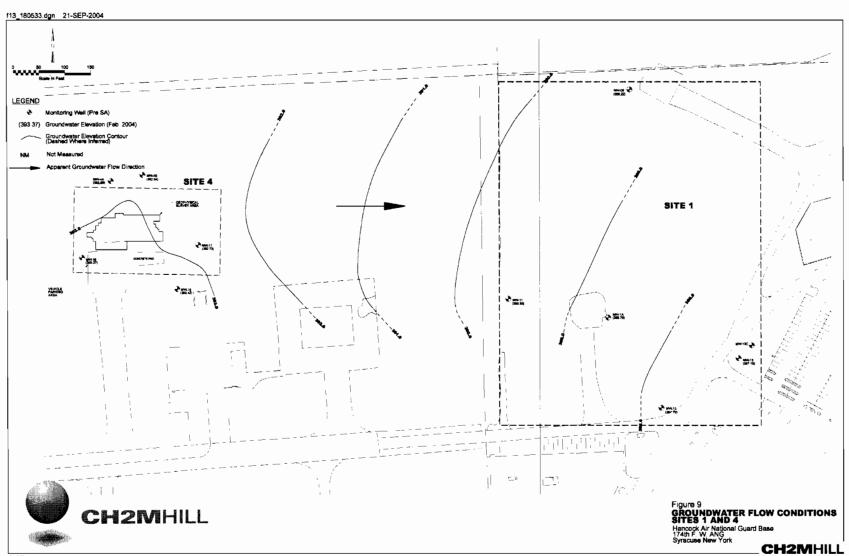
Groundwater Flow Conditions

- Measure groundwater elevations in 7 existing and 3 newly-installed overburden monitoring wells in February 2004
- Groundwater elevations range from 387.16 ft to 393.42 ft above Mean Sea Level
- Flow is generally east under hydraulic gradient of 0.005 ft/ft.
